**Field Oversight Summary  
Materials Handling Treatability Study  
American Chemical Services, Inc.**

**July 1997**

USEPA Region 5  
American Chemical Services  
Field Oversight  
Materials Handling Treatability Study

BVSPC Project 71670  
BVSPC File D.3  
August 28, 1997

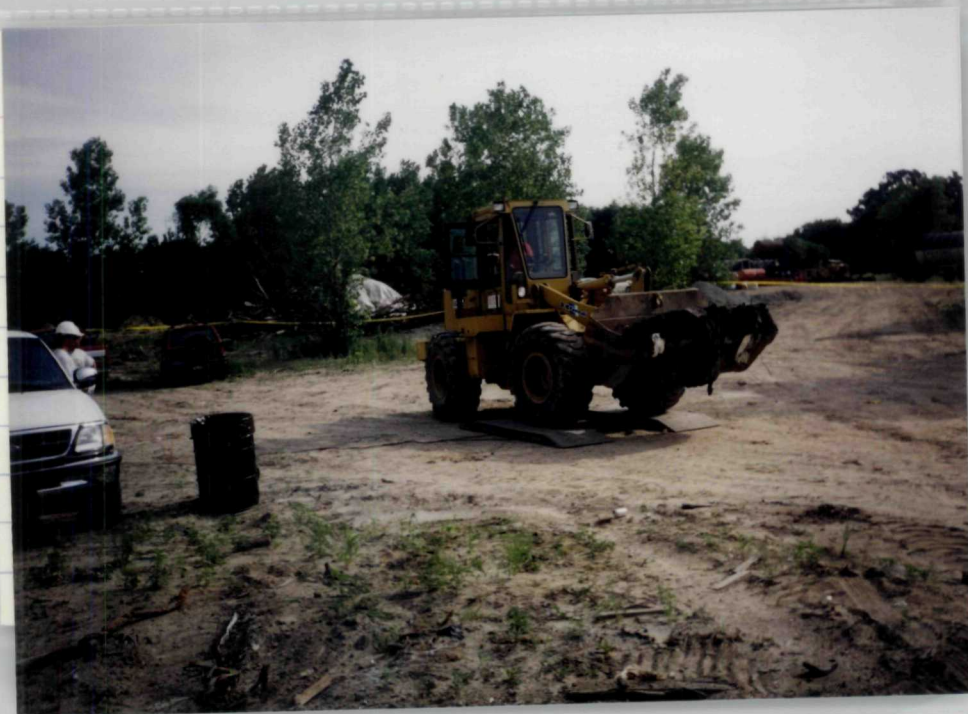
0820 Begin Trench 7 along S side of SA01. Drums at 12 inches below grade. Drums end at 20 feet south of SA01. Depth of 10 feet found clean sand. Lot of debris mixed with soil. Backfill the trench. Photo 15 looking SE showing the backfilling at 0845.

Site: American Chemical Services, Inc. RD/ERA  
 Project: 71670  
 Photo: 15  
 Date: 7/17/97 Time: 0845  
 Photographer: Steve Mrkvicka  
 Description: Looking southeast at backfilling of Trench No. 7 located  
 along southern side of SA01.

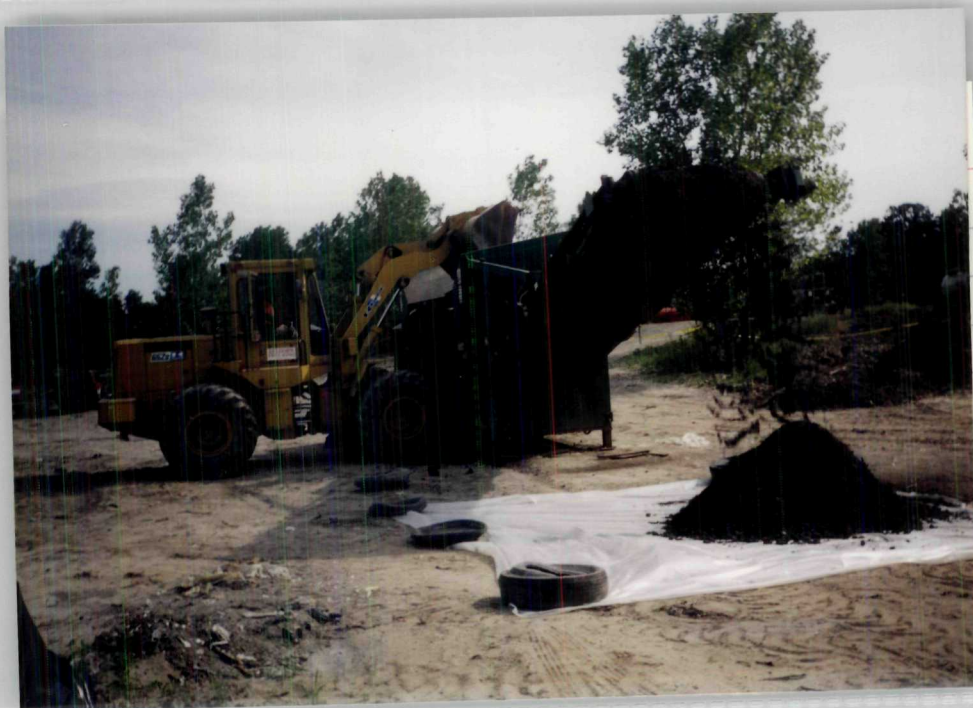
0855 Move to Trench 8 South along SA02. Large amount of debris mixed with soil. Photos 16 and 17 looking NE into Trench 8. Drums at about 6 feet bgs.

Site: American Chemical Services, Inc. RD/ERA  
 Project: 71670  
 Photo: 17  
 Date: 7/17/97 Time: 0855  
 Photographer: Steve Mrkvicka  
 Description: Looking northeast into Trench No. 8. Drums encountered at about 6 feet below ground surface.

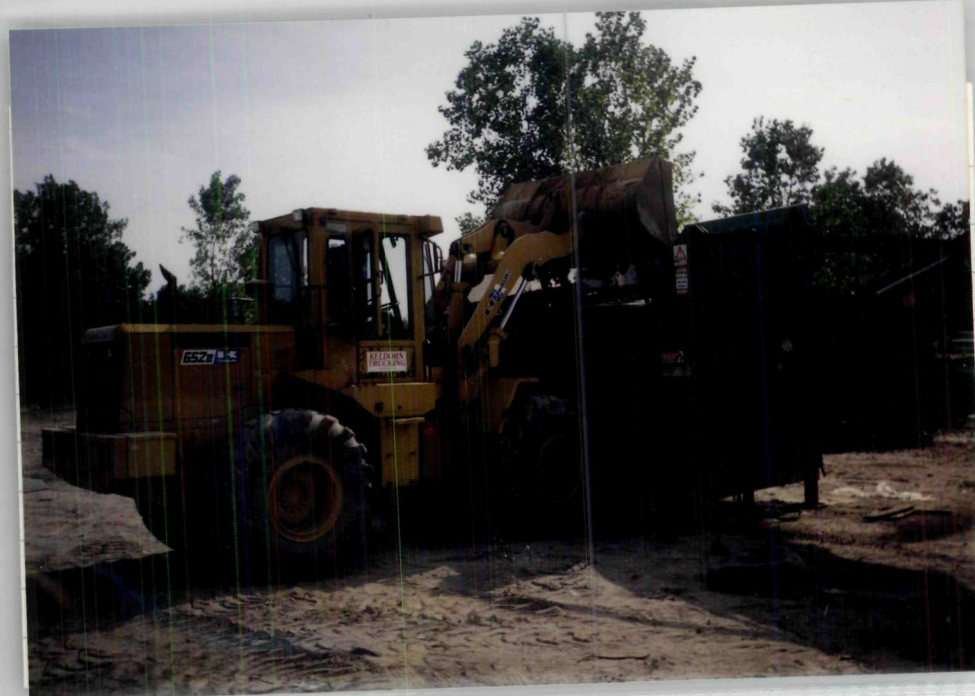
Photo 20 Fine soil deposited off conveyor belt.

Site: American Chemical Services, Inc. RD/ERA  
 Project: 71670  
 Photo: 20  
 Date: 7/17/97 Time: 0920  
 Photographer: Steve Mrkvicka  
 Description: Looking northeast. Finer material is deposited off the conveyor belt.
